SOHO

Update on the wheel speed anomaly

Ref: SOHO/PRG/TN/549, issue 1.0, 2002.FEB.25

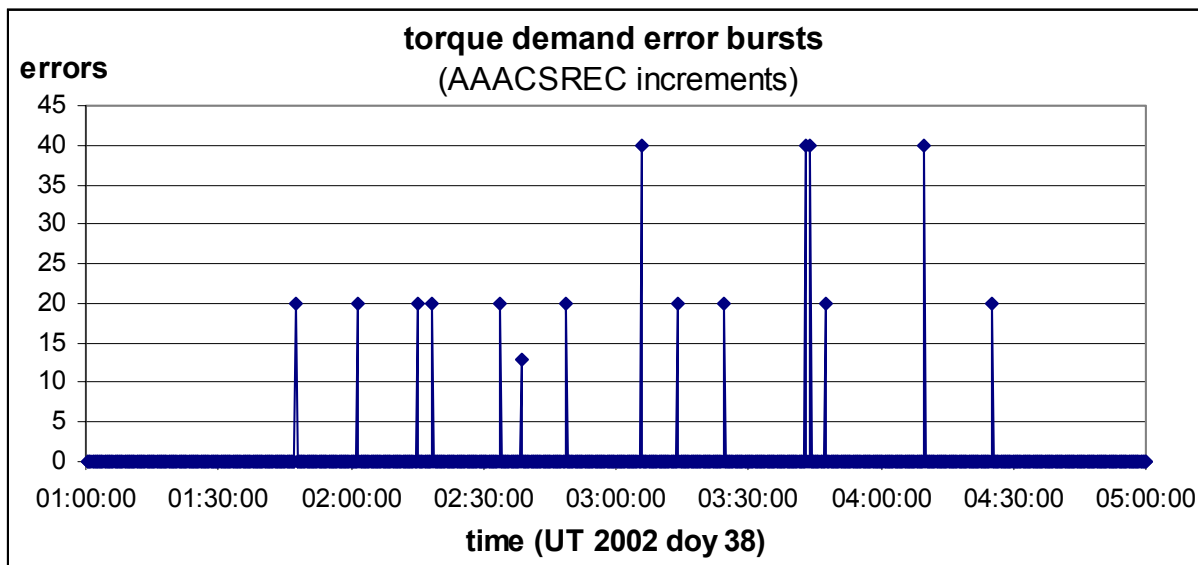
On 2002-Feb-07 (doy 038), while in CRP as part of the recovery from ESR# 18 (Bus Voltage drop incident), a total of 373 wheel torque demand errors were reported by the ACU software, between 01:46 and 04:24 UT (spacecraft anomaly S02-0017). These errors occurred in 15 bursts of 20 or 40 contiguous errors. One of the bursts had 13 errors only.

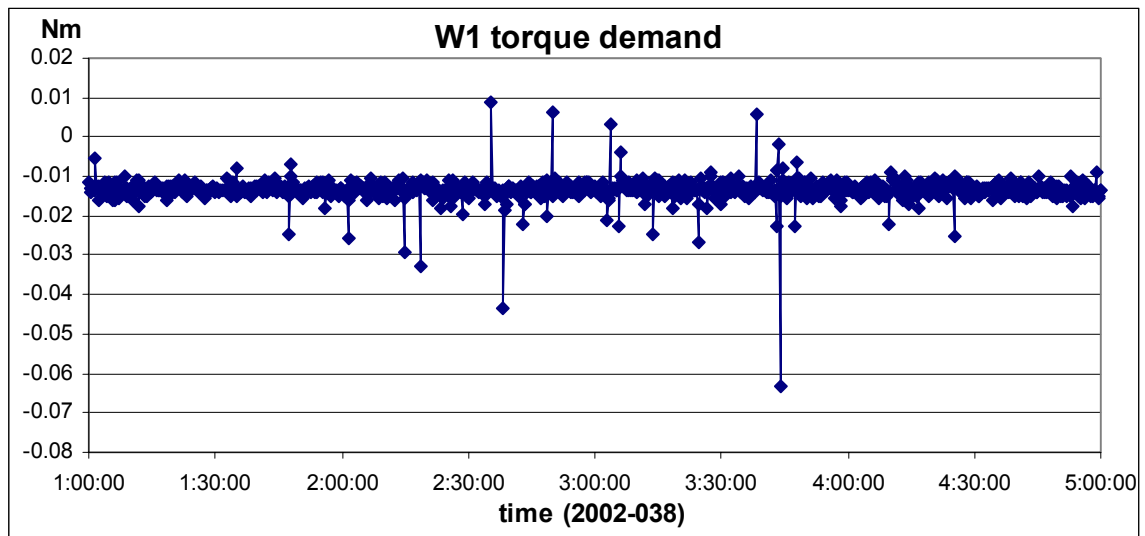
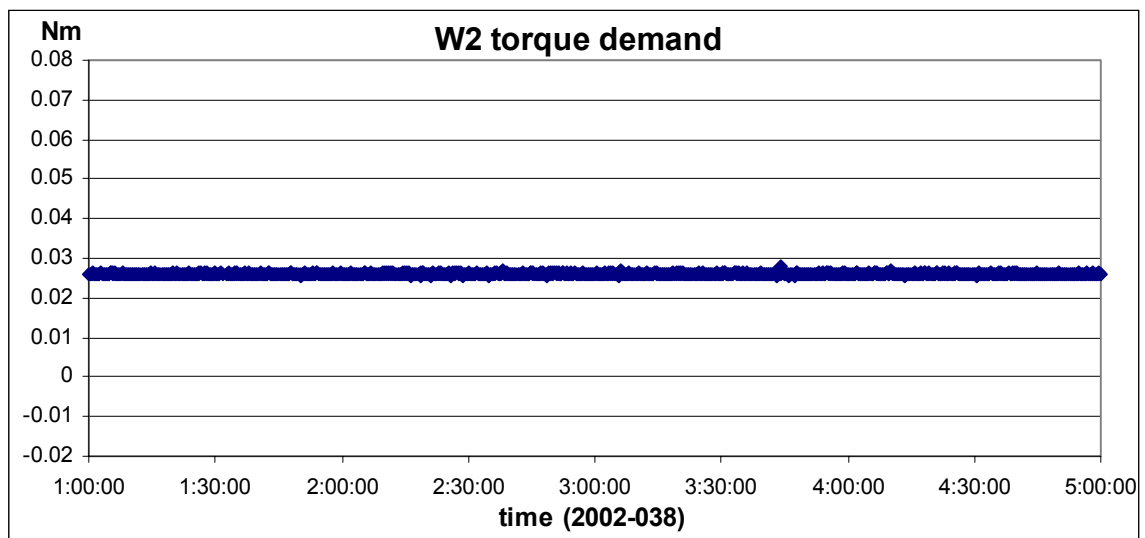
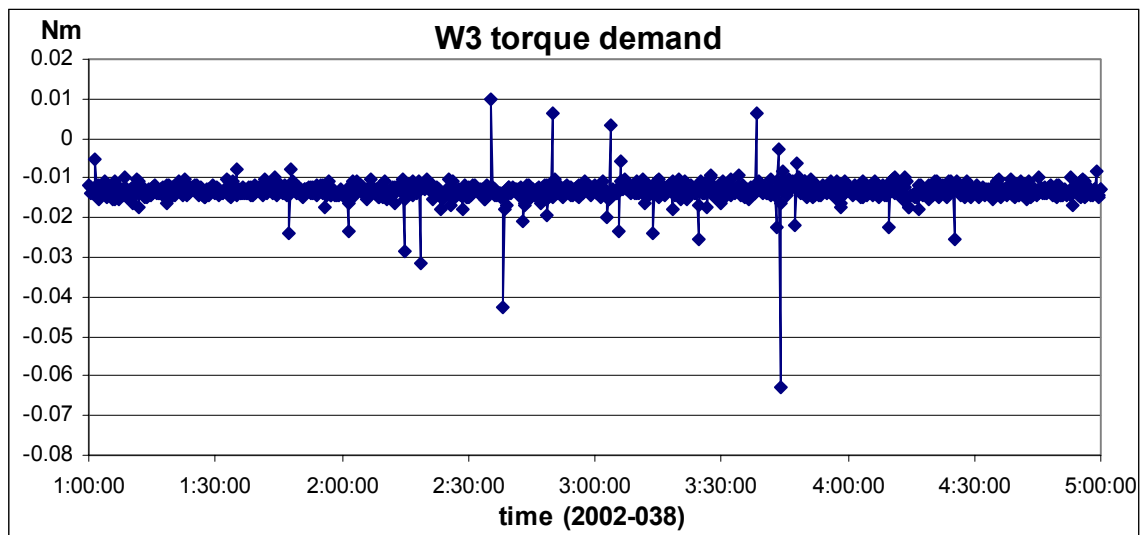
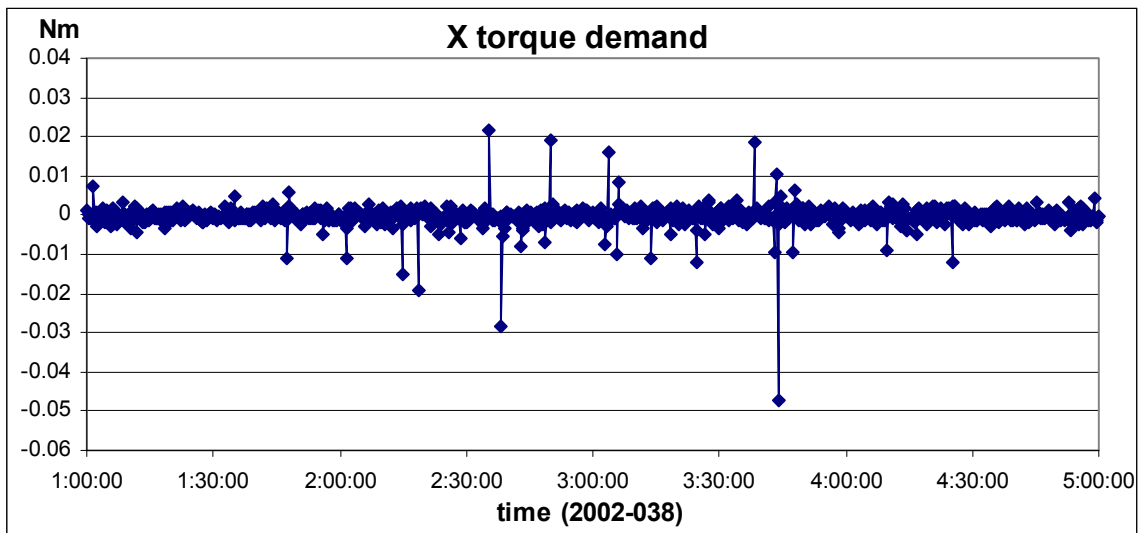
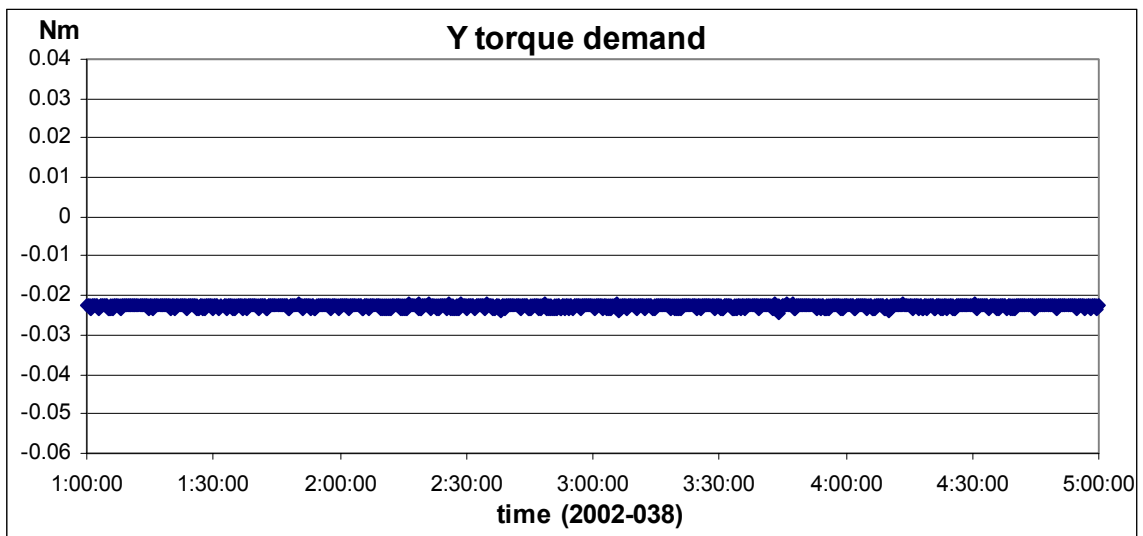
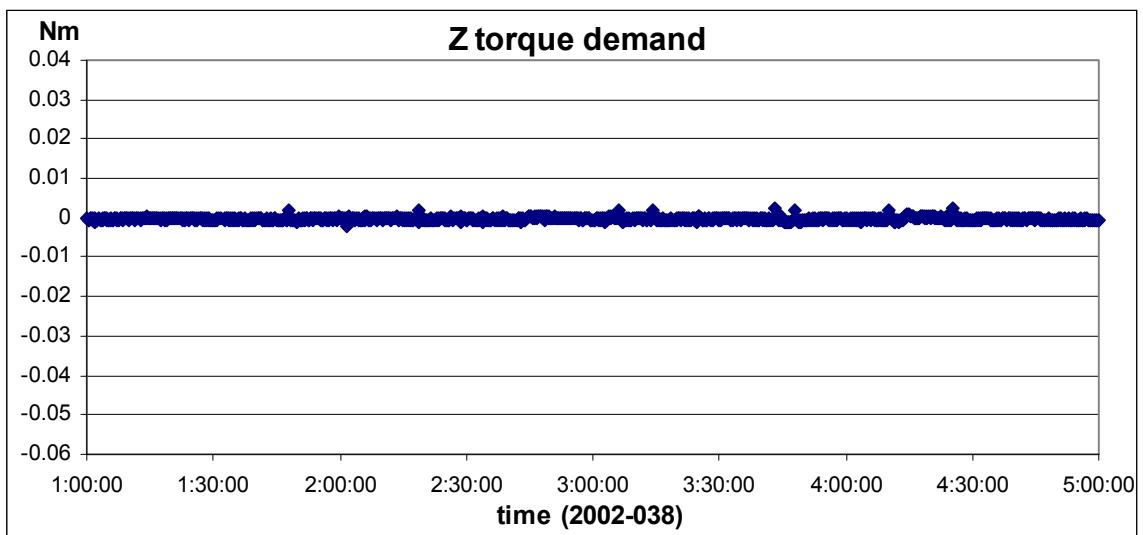
Analysis of the telemetry showed that the unusual torque demands had identical profiles on wheels 1 and 3, ruling out any mechanical problem on a wheel. The conversion of the three wheel torque demands to spacecraft frame, showed that the problem was actually **abnormal roll torque demands**, while pitch and yaw torques were normal.

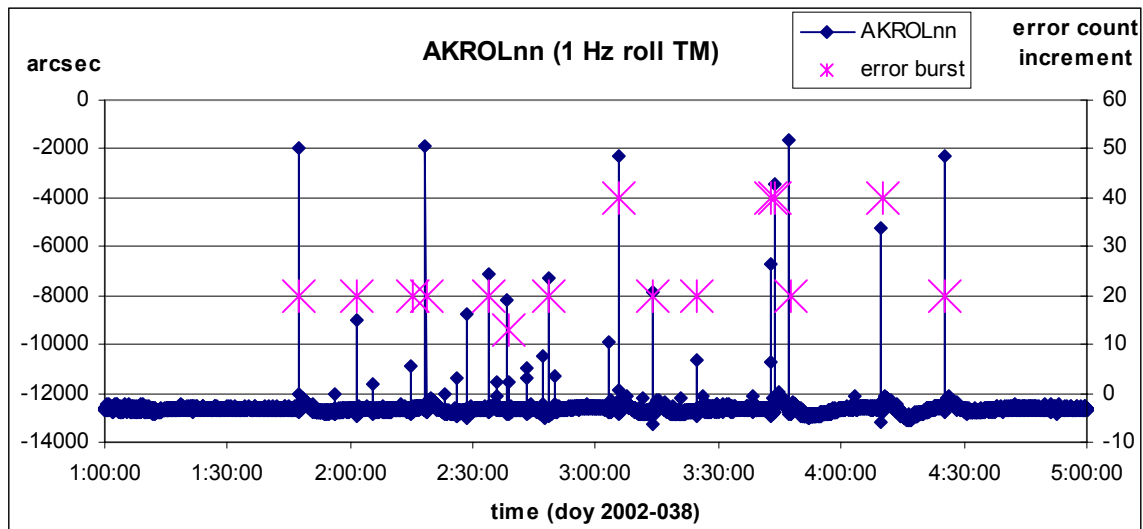
The abnormal roll torque demands pointed to a problem with the CRS angle measurement, which serves as input to the CRP roll controller. Indeed, the 1 Hz roll telemetry (AKROL00-14) displayed many important glitches, with roll errors in the order of 3°. The larger roll telemetry glitches coincide with the error bursts.

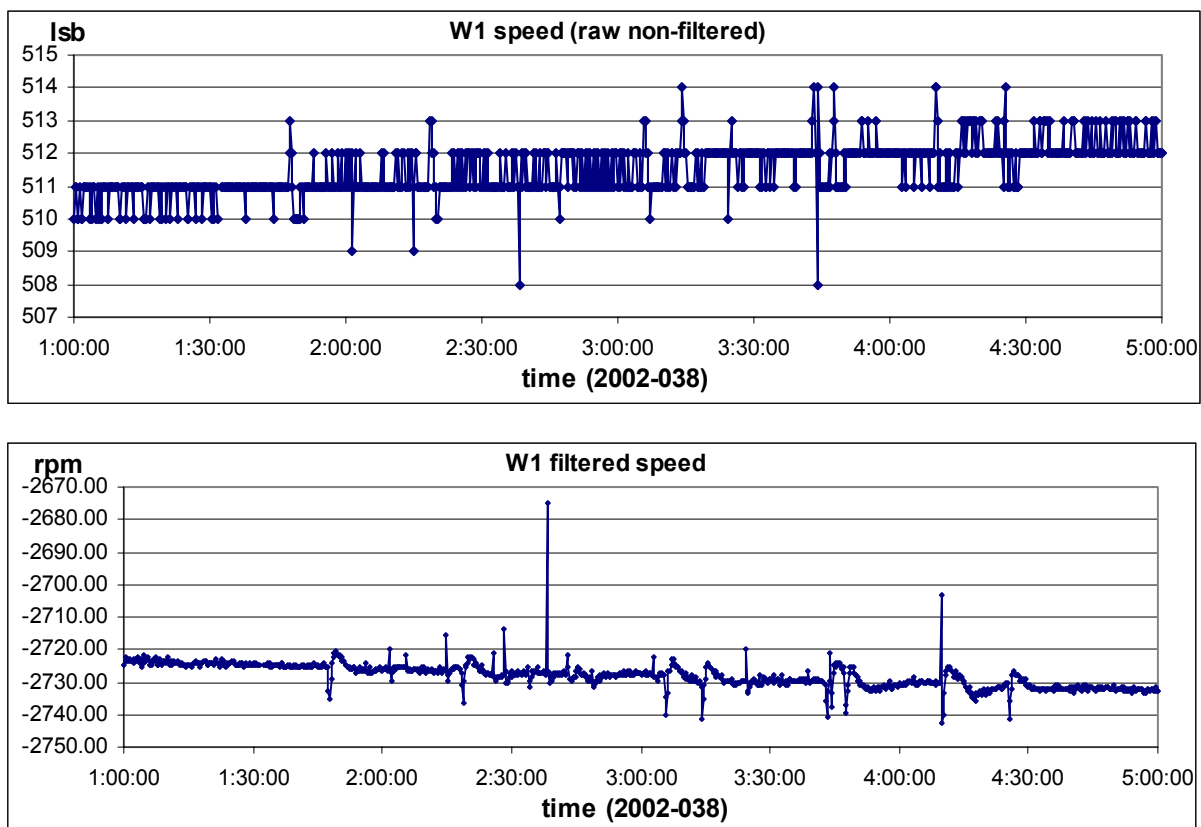
During the torque-demand-error episode, on 2002-Feb-07, the large number of the wheel speed telemetry corruptions, observed in such a short time, did not fit with the prevailing theory of occasional single "1" to "0" bit flips.

It is interesting to note that the corruptions occurred only when the speed was between 511 and 512 raw counts. There are no corruptions between 510 and 511, and, most remarkably, there are no corruptions between 512 and 513. Thus, the anomaly is not directly related to the "infamous" 512 (0010 0000 0000 bin) value, for which a single bit-change can give a faulty 0 rpm reading. This showed that our previous understanding of this anomaly was incorrect.

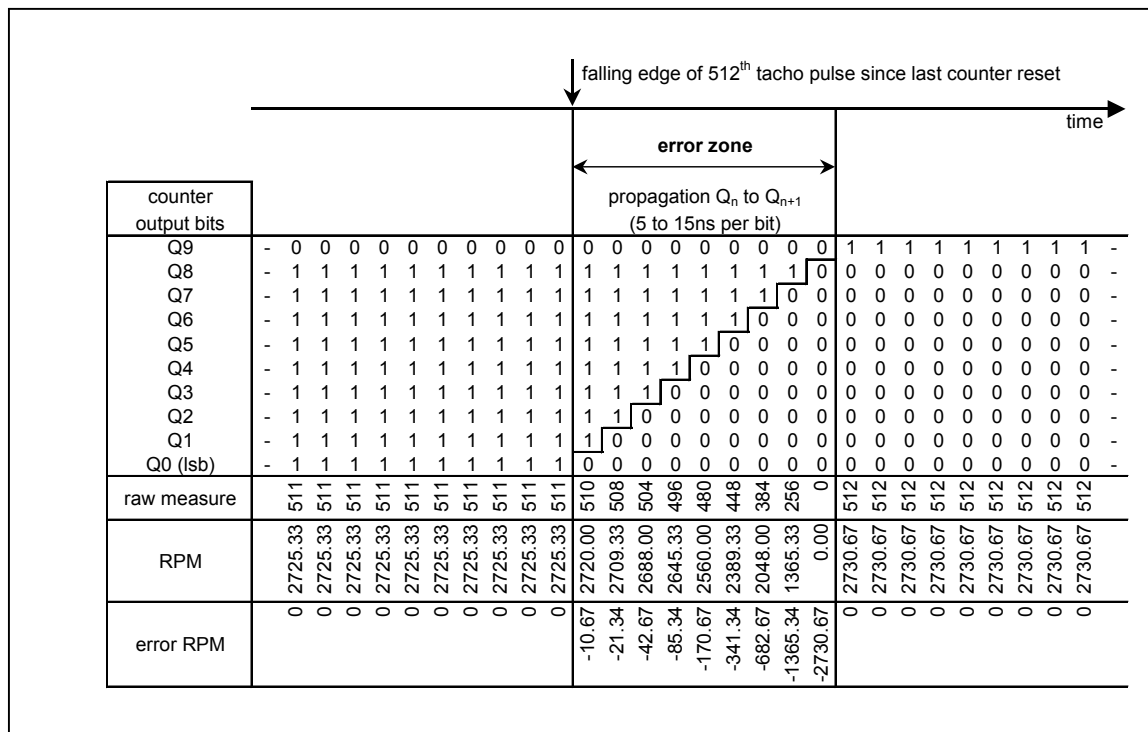
Counter timing diagram

The HC4040 datasheet specifies that the propagation delay, from one counter stage to the next (Q_n to Q_{n+1}), is between 5 and 15ns, depending on supply voltage and temperature. Consequently, if the current count ends with consecutive “1” bits, the next increment will result in the propagation of a carry through several stages of the counter. Until the propagation is over, the counter outputs are incorrect. The following figure illustrates this.

If the end of the 46.875ms timing window occurs in the carry-propagation "error zone", then a wrong measurement is latched.

However, it could be possible to design a simple ACU software patch in order to filter-out the erroneous wheel speed measurements and avoid the adverse effects of this anomaly.

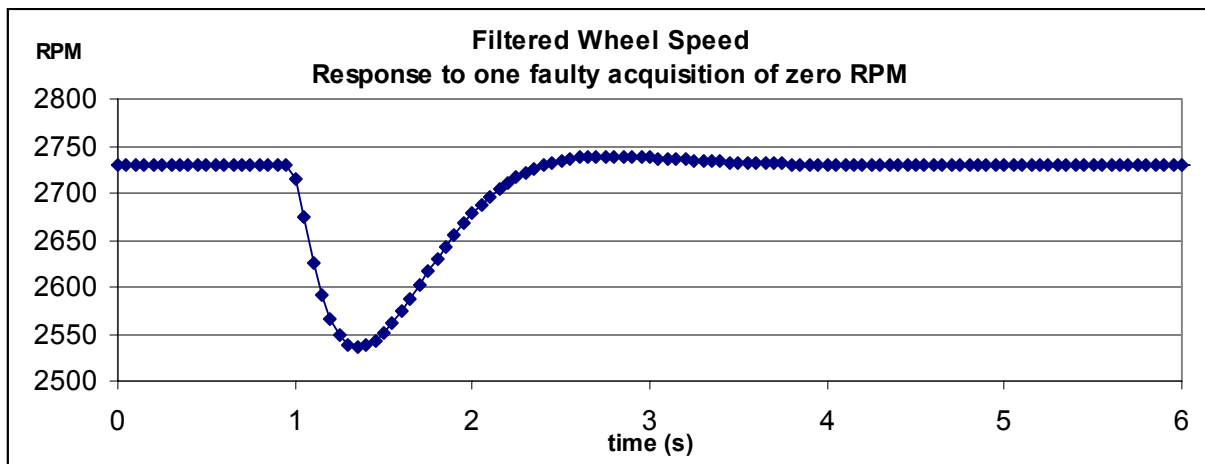
In CRP, the roll attitude is given by the CRS angle, which is derived from the filtered wheel speeds.

During the torque-demand-error episode on 2002-Feb-07, the 1Hz roll telemetry showed errors in the order of 3° . These erroneous inputs have disturbed the roll control and resulted in actual roll offpointings in the order of 0.1° .

A worst case analysis shows that the error on the CRS angle, due to a single faulty acquisition, can reach 54° , with wheel speeds of 2730/ 190/ 2633 rpm for example. This would result in an actual roll offpointing in the order of 1.8° . In theory, a 180° roll telemetry error is possible during a roll profile with wheel speeds of 2730/ 0/ 2550 rpm for instance.
